Technical Report HL-96-18
September 1996

Channel Stability Study, Flamingo Wash, Las Vegas, Nevada

by Ronald R. Copeland, Lisa C. Hubbard

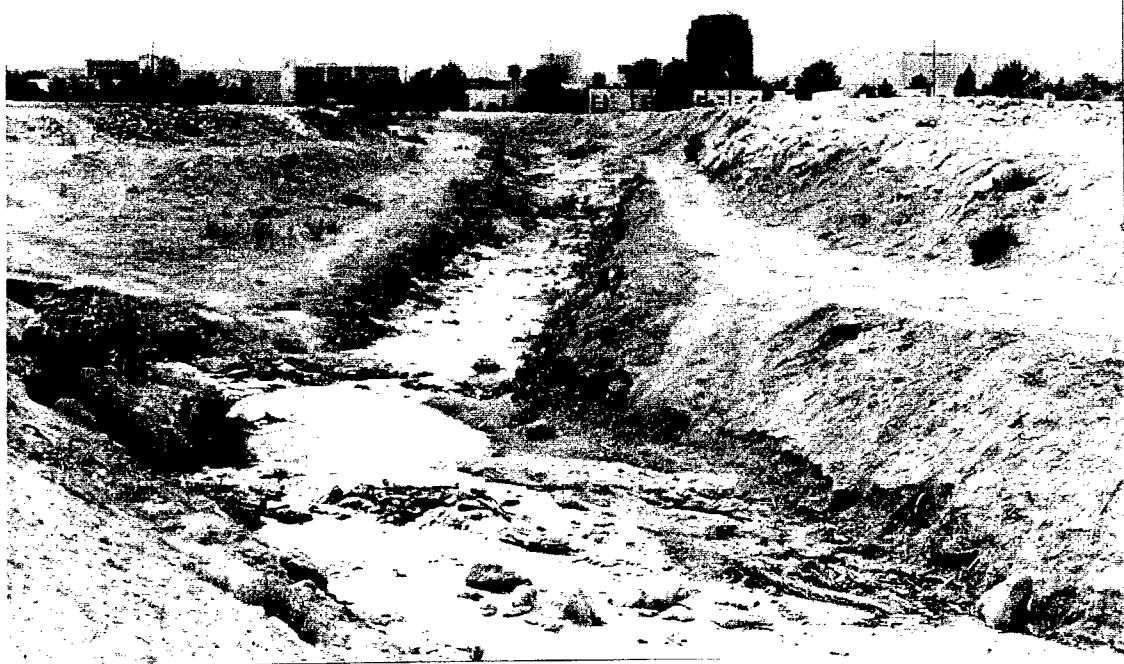
Figure 9. Flamingo Wash - Reach 6, looking upstream from the Tropicana Wash confluence, April 1995

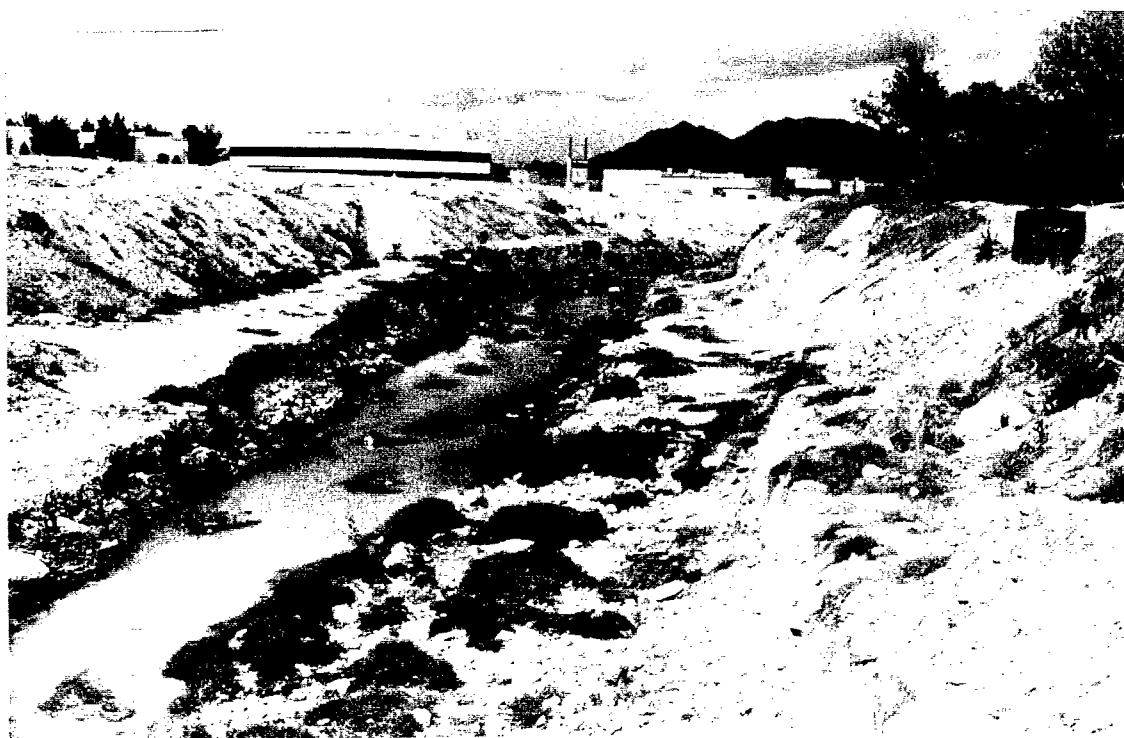
Downstream from Cambridge Street the graded channel generally had a trapezoidal shape with a 10-ft-wide low-flow channel cut to a depth of 4 to 5 ft (Figure 10). The nearly vertical upper banks consisted of sand and gravel. The bank material was quite hard even though the presence of significant cohesive material was not apparent. The upper layers of these banks were composed of loose material. Concrete-lined bank protection extended about 100 ft upstream from Maryland Parkway on the right bank, and about 300 ft upstream on the left bank. The concrete-lined side slopes were not keyed into the bed. Generally, the bottom elevation of the slab was at the existing channel bed elevation. However, erosion had occurred at the base of the lined side slopes at several locations (Figure 11). Further erosion could undercut the slabs and cause failure along a significant reach of the channel. Geometric irregularity associated with slab failure would accelerate the local erosion process. A plan view of reach 7 is shown in Plate 7.

Figure 10. Flamingo Wash - Reach 7, looking downstream from Cambridge Street, April 1995
